Stream Corridor Ecological Restoration by Small Dam Removal

- Removals of Gongreung2 & Gotan Small Dams in Korea -

Hong-Kyu Ahn* · Si-Nae Kim* · Hyo-Seop Woo**

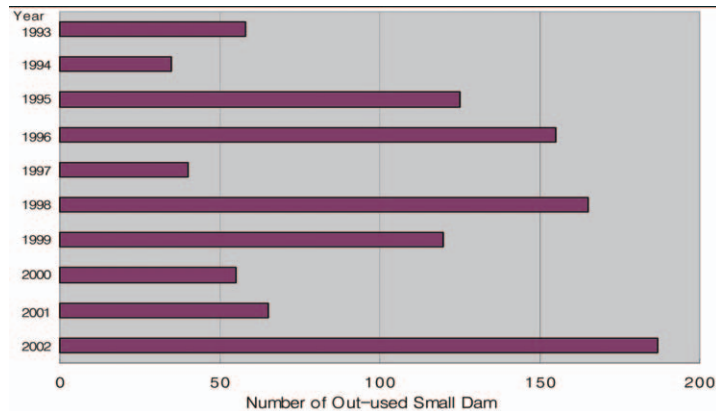
Fig. 1. Number of Out-used Small Dam by year in Korea

In addition, 50-150 small dams that lost functions are annually abandoned, due to urbanized farm land, changes in farming land including change from rice farming to vinyl house farming, integration of water collection facilities deriving from large reservoirs construction and pumping stations installation, and aging facilities(KRC, 2001). For the abandoned small dams, the structures are not completely removed out of the streams, but most still remain in the streams, or eco corridors like fishways are artificially installed in minimal number of small dams. Therefore, those abandoned small dams continuously cause problems including the interruption of stream eco corridors and deterioration of water quality and the habitat of riparian organisms.

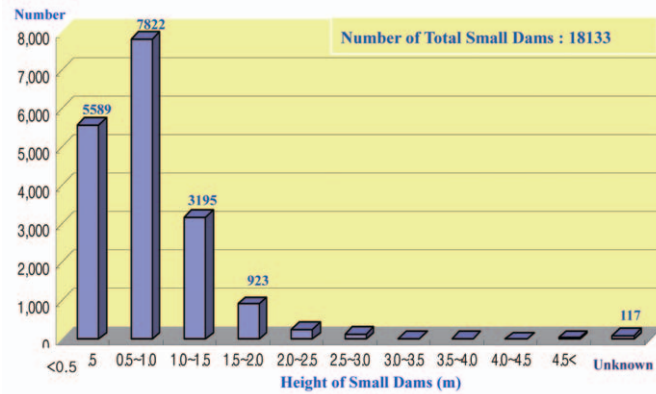
Fig. 2. Number of Korea's Current Small Dams by Height

In case of Korea, about 18,000 small dams are located nationwide. Among them, the small dams with 1.0m or lower in height accounts for 70%. About 25% of them shows 1.0-2.0m in height and about those with higher than 2.0m in height takes up 5%(KRC, 2001).

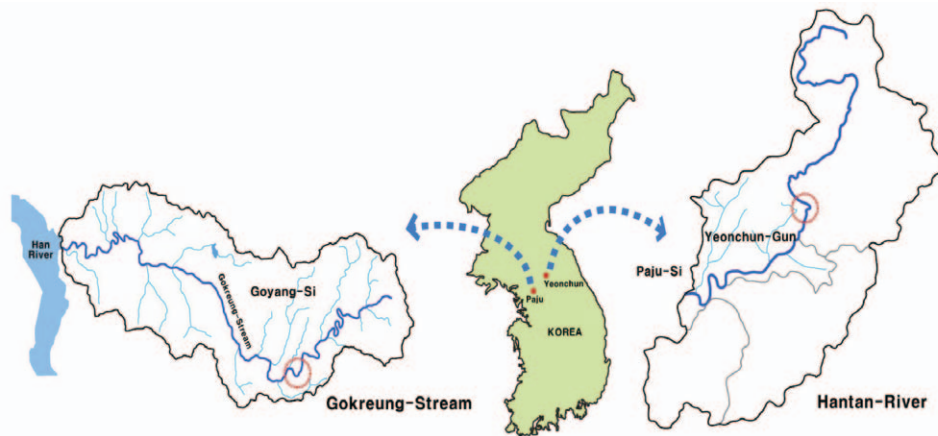
Fig. 3. Study sites

The study chose Gongreung2 small dam (length: 76m, height: 1.5m) in the upper reach of the Gongreung Stream located in Goyang City and Gotan small dam(length: 190m, height: 2.8m)

located in the Hantan River, Yeoncheon-gun, Gyeonggi-do as study sites.

Gongreung2 small dam was built to supply agricultural water in the 1970s, and was reinforced in several occasions. However, it lost its use, because of changed water collection method, deriving from the conversion of surrounding farming land into vinyl house complexes starting the 1990s. The basin area of Gongreung stream is 253.1 km² and river bed slope is 1/200 (Gyeonggi-do, 2002).

Gotan small dam was installed in order to supply water for local residents in 1991, but lost its function as a small dam to collect water, since water supply source was relocated, due to pollution of water in the upper reach of the small dam. The basin area of the Hantan River is 2,436.4 km² and river bed slope is 1/950 (Gyeonggi-do, 1998).

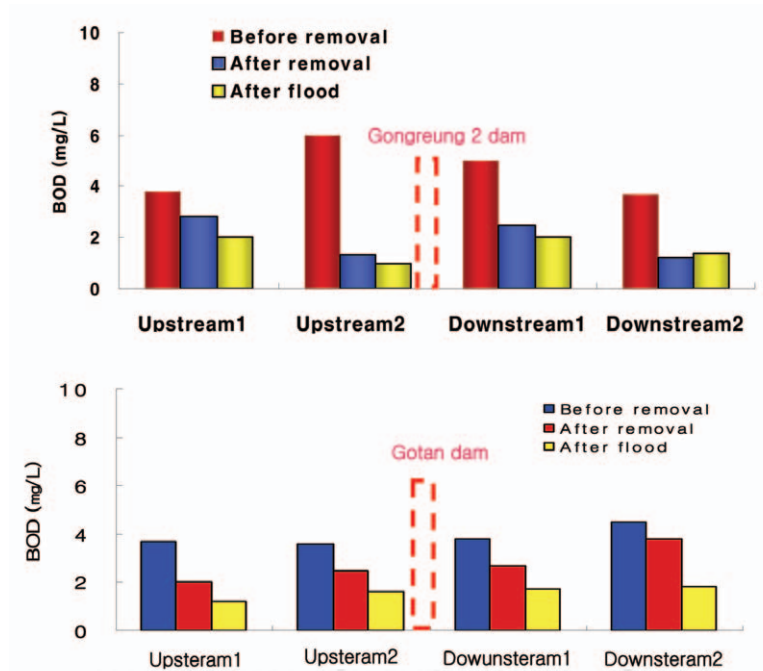
Fig. 7. Changes in BOD and SS concentration of Gongreung2 small dam(up) and Gotan small dam(down) before and after small dam removal

The analysis of the mean concentration of BOD, SS and TN and TP showed that the concentration of SS was lower after the dam removal than before the dam removal except for in the uppermost reaches of the small dam, and that of BOD had significant lower values of both of the after the dam removal than before the dam removal.

These results indicate that the water quality got better after the small dam removal than before the dam removal. However, as the monitoring was conducted over a short period of time after the dam removal, it is too early to come to any quantitative conclusion, and a longer-term

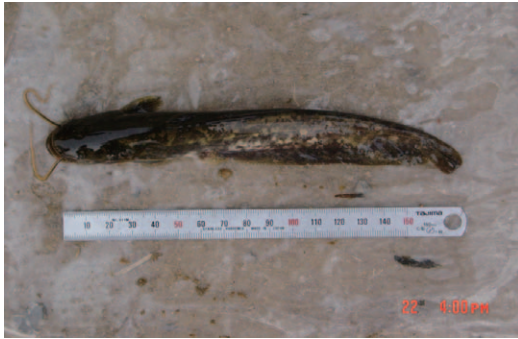
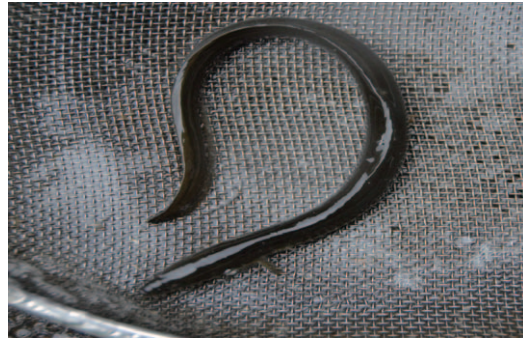
Fig. 10. The photo of the Far Eastern Catfish(left:Gongreung2 small dam) and eel(right:Gotan small dam) be found in the upstream after the dam removal

Also, fish such as catfish and eels whose movements were obstructed by structures such as small dams before are discovered now in the upper reaches of the small dams.

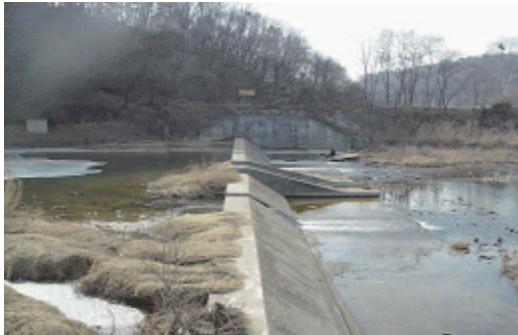
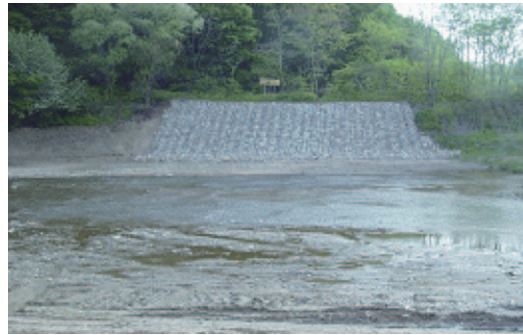
Fig. 11. The photo of Gongreung2 small dam before(left) and after(right) the dam removal(opposing the left bank of the small dam)

In the Gongreung2 small dam in the Gongreungcheon whose riverbed was made up with sand, swamps in the upper and lower reaches of the small dam quickly changed to rapids after the removal of the small dam whereas swamps in the Gotan small dam in the Hantan River whose riverbed consists of gravel is very slowly changing to rapids.

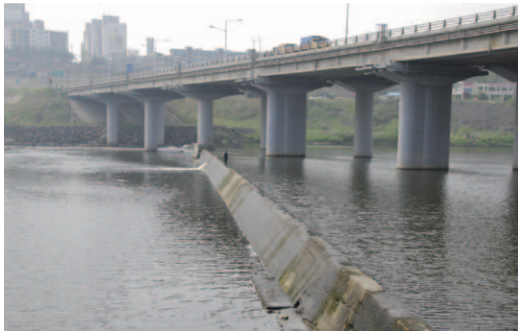
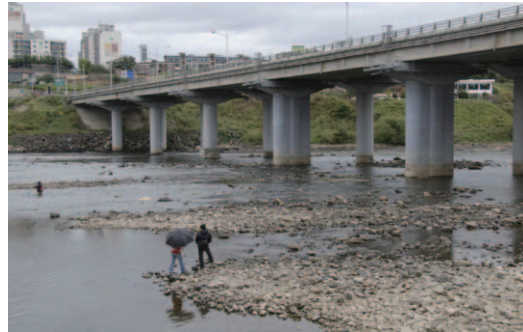
Fig. 12. The photo of Gotan small dam before(left) and after(right) the dam removal(opposing the right bank of the small dam)
