## Rajakudakan Wat Chotikaram: From Ruins to The Reconstruction of The Grand Stupa, Wat Chedi Luang, Chiang Mai\*

The Grand Stupa is mentioned in historical text as 'Rajakudakan', which means a royal building with a multitiered superstructure. This Grand Stupa is the principal construction of Wat Chedi Luang, and marks the center of the Chiang Mai City Plan.

This study argues that the Grand Stupa was built in 1391 during Phaya Saen Mueang Ma's reign, possibly inspired by the construction of Ku Phaya in Bagan. Thereafter, in 1545, the Grand Stupa's superstructure collapsed after the great earthquake, resulted in the irreparable damage since then. Therefore, a survey using a 3D laser scanner is conducted to collect the most precise data on the current condition of the Grand Stupa, yielding an assumption of its reconstruction.

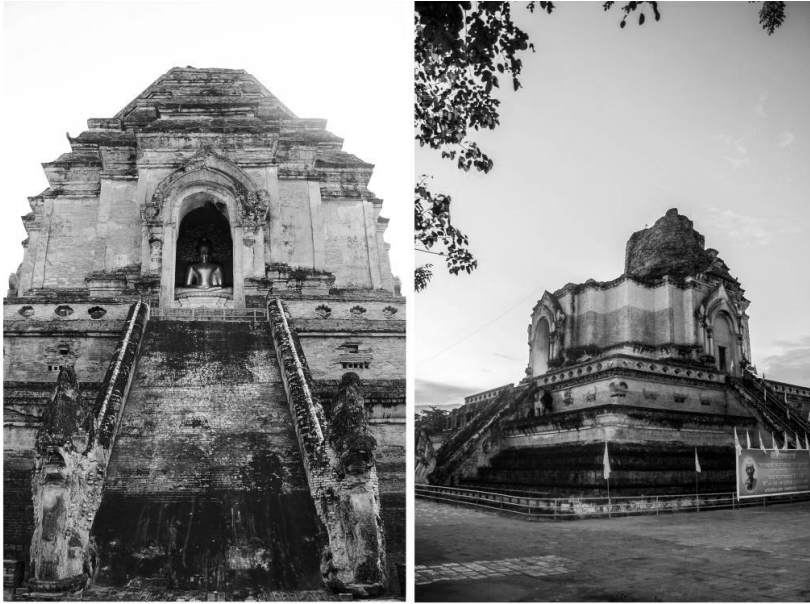
<Fig. 4> Current architectural condition of the Grand Stupa with its damaged superstructure, Wat Chedi Luang

Thereafter, in 1545, the superstructure of the Grand Stupa collapsed after an earthquake during the reign of Queen Jiraprap <Fig. 4>. Remarkably, it resulted in the irreparable damage of the Grand Stupa's superstructure since then (Ongsakul 2009: 177).
