A Study on the Systematic Cause Analysis of Shipboard Fire Accident Case using STAMP Methodology

[Abstract]

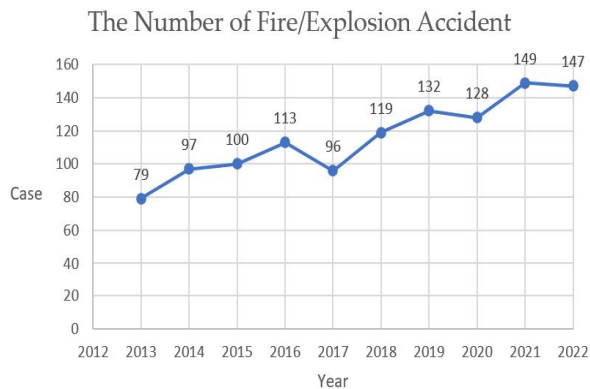
Fig. 1. The Number of Fire/Explosion Accidents

Vessel assume a pivotal role in the realm of maritime transportation, serving as the primary ways and means responsible for the movement of goods and people. When ships set sail on the open sea, the paramount concern shifts from rapid arrival to prioritizing safety, owing to diverse array of risks inherent in shipping operation. Among these risks, onboard fires pose a particularity grave threat, given that a single occurrence can result in substantial damage to the vessel, its cargo, and the personnel like onboard passenger and crew. accidents involving fires during a voyage have persistently plagued the industry. According to maritime accident statistics compiled by the Korean Statistics Information Services(KOSIS) over the past decade, commencing in 2013, as illustrated in Fig. 1, such accidents have demonstrated a consistent upward trend[1].

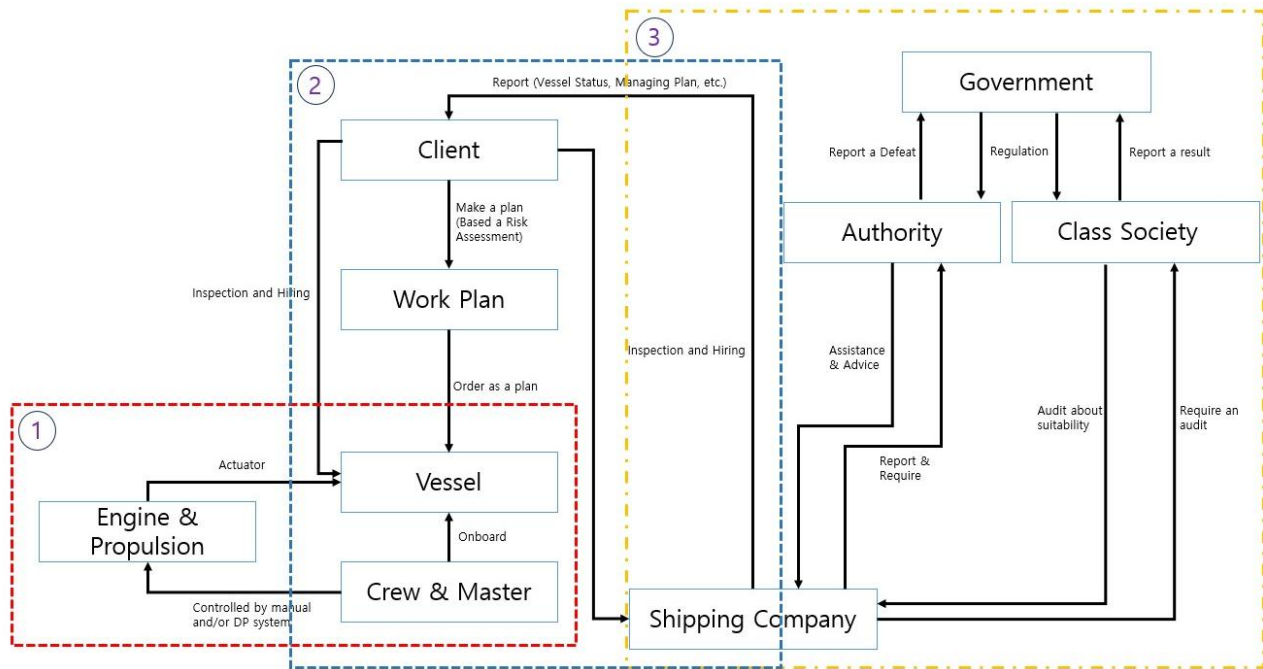
Fig. 2. Control Structure of Case Study

To conduct STAMP analysis for the accident, it has constructed a control structure for the ship and its operational system as depicted in Fig. 2.
